UNDERWATER BRIDGE INSPECTION REPORT

STRUCTURE NO. 57518
CSAH NO. 3
OVER THE
RED LAKE RIVER
DISTRICT 2 - PENNINGTON COUNTY

PREPARED FOR THE
MINNESOTA DEPARTMENT OF TRANSPORTATION
BY
COLLINS ENGINEERS, INC.
JOB NO. 5221 (CEI 9A)

MINNESOTA DEPARTMENT OF TRANSPORTATION
UNDERWATER BRIDGE INSPECTION

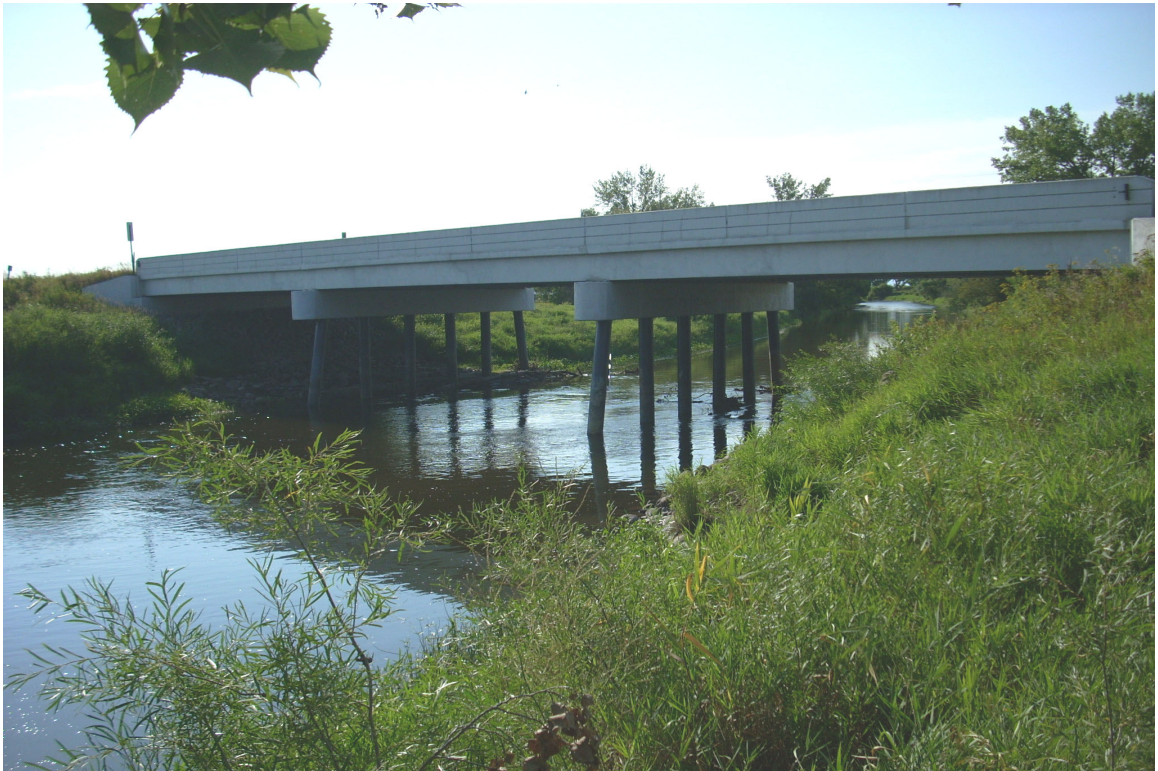
Photograph 1. Overall View of Structure, Looking Southeast.

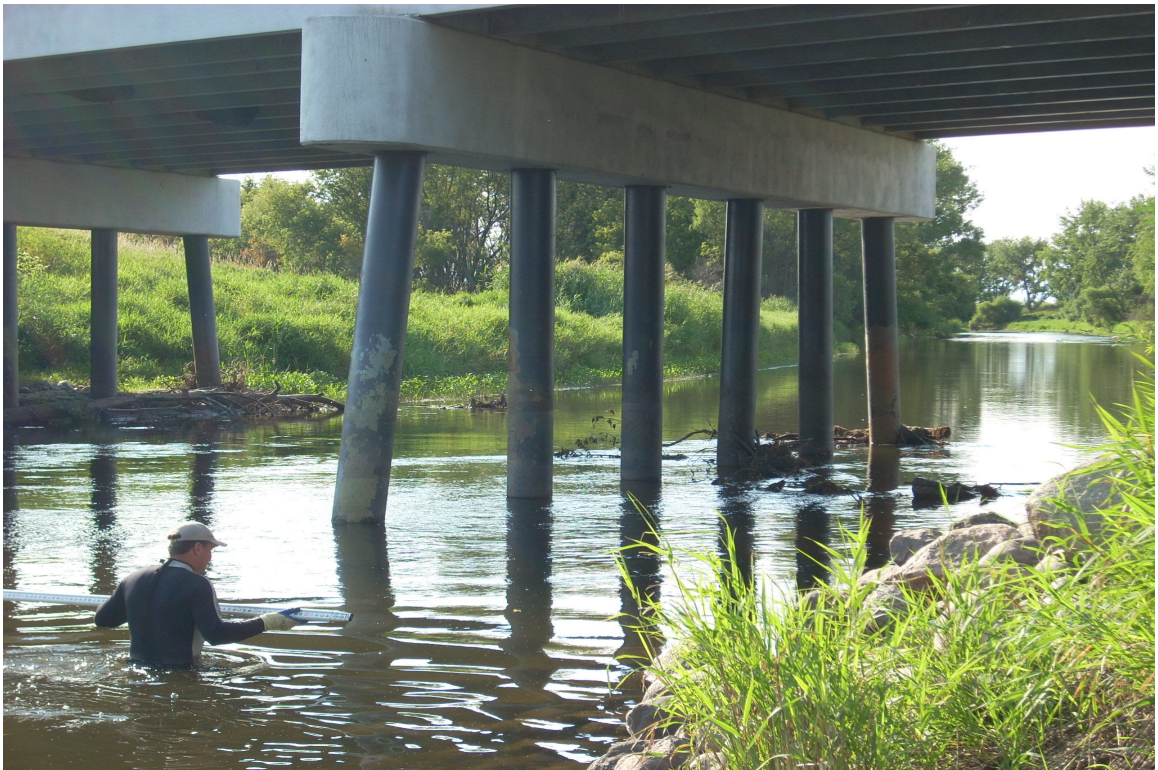
Photograph 2. View of Pier 1, Looking Southeast.

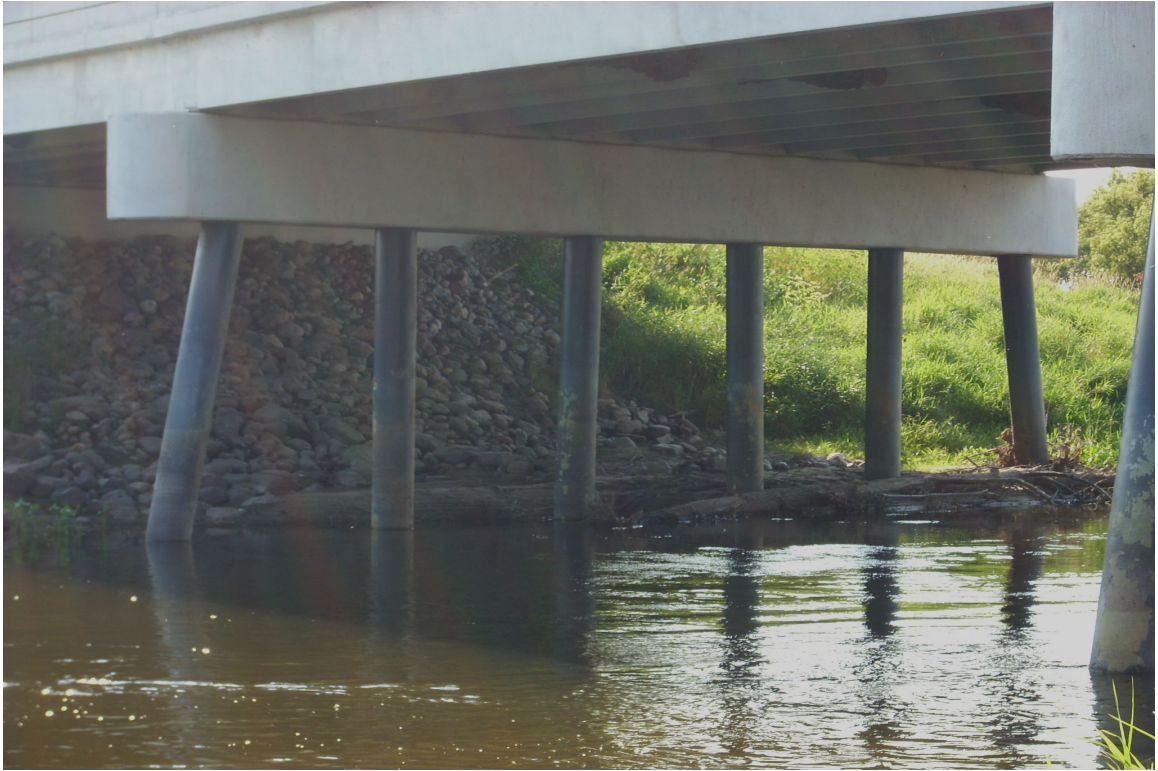
Photograph 3. View of Pier 2, Looking Southeast.

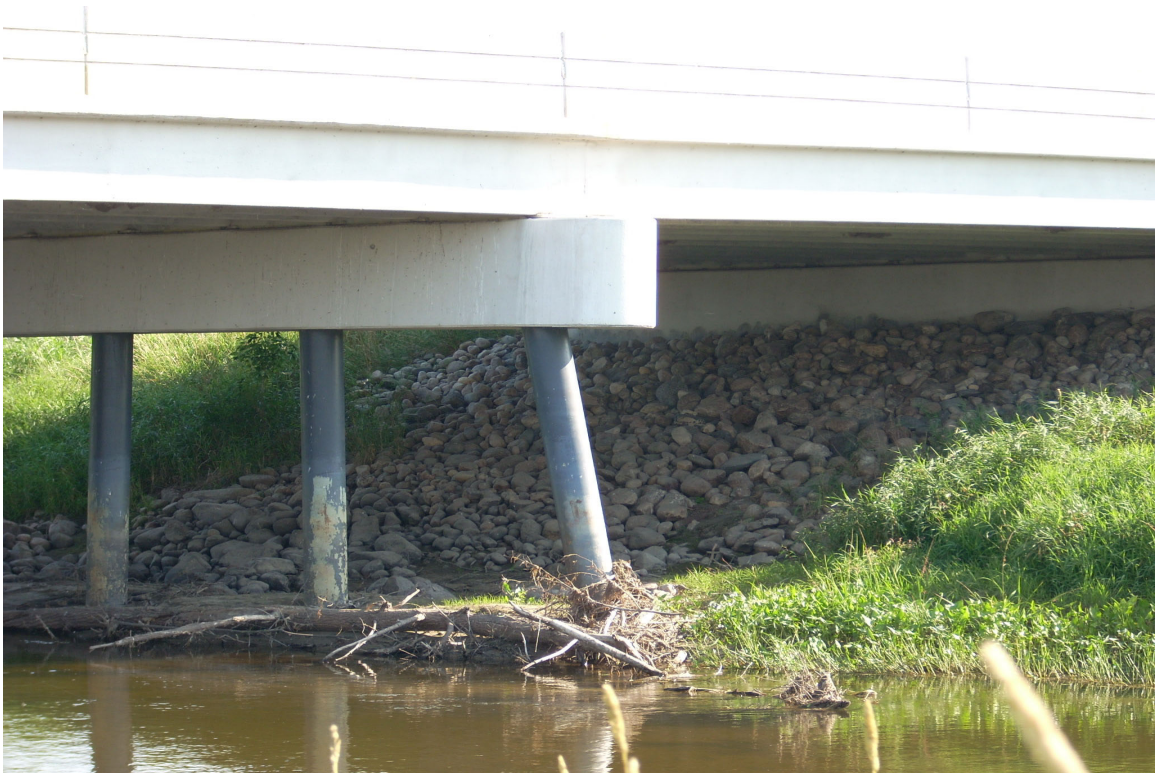
Photograph 4. View of Debris at the Upstream Piles of Pier 2, Looking Northeast.

- The channel bottom material around Piers 1 and 2 consisted of sand with 12 inches of probe rod penetration.
- A light to moderate accumulation of 1-foot-diameter and smaller timber debris and organic material was observed around Piles A through D at Piers 1 and 2.
- The steel pipe piles exhibited coating failure and random areas of minor surface corrosion with no appreciable loss of section over approximately 50 percent of the surface area from 5 feet below the top of the piles to the channel bottom.

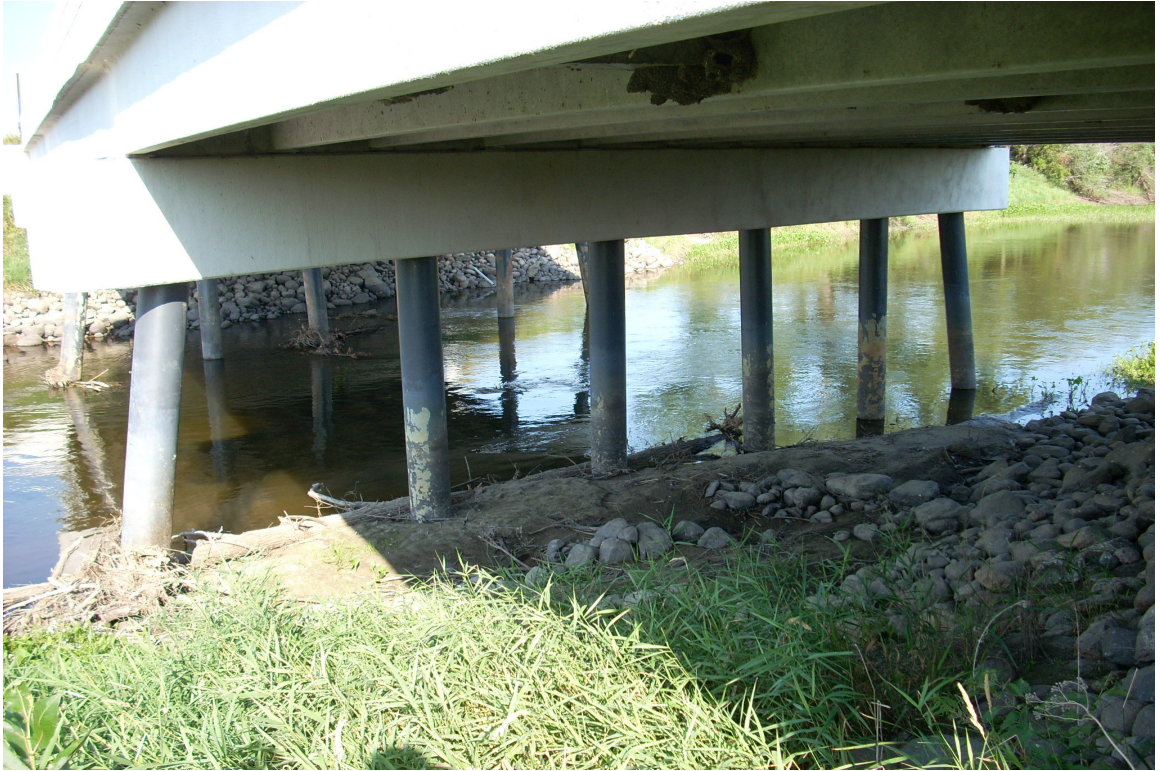
Photograph 5. View of Pier 2, Looking Northwest.
